GLOBAL SMT & PACKAGING

Volume 8 Number 5 May 2008

Ball grid array & lead-free assembly defects, part 1

Ball grid array & lead-free assembly defects, part 2

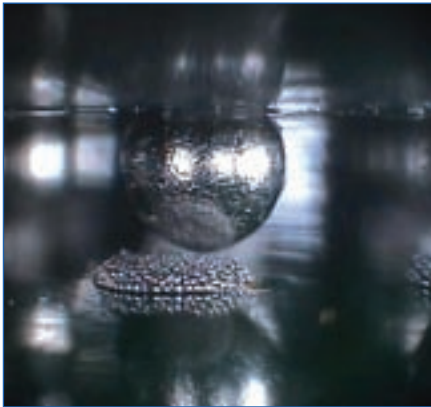
Figure 1. The BGA package has not been placed into the paste deposit.

Poor Placement Force Control

In Figure 1, the BGA package has not been placed into the paste deposit; the ball terminations are sitting proud of the surface of the paste. This may be due to uneven paste deposits, a warped BGA or a random chip component under the BGA, which does happen from time to time.

There is also some evidence of print misalignment on the board. Provided the ball was placed into the paste, and at this pitch, a satisfactory joint should be achieved during reflow. Unfortunately the lifted termination may not allow this to happen.

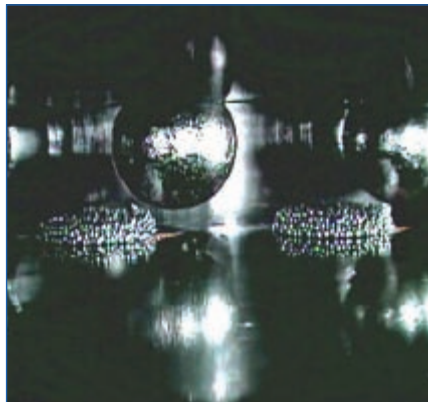
Figure 2. Solder paste deposit is not correctly aligned with the pads.

Misalignment of solder paste deposit

Figure 2 clearly shows that the solder paste deposit is not correctly aligned with the pads on the surface of the board. The relative placement position of the BGA is within the limits of reflow to re-centre the part. However, correction should be made for placement error. In this situation, with error on placement and paste, the coarse-pitch BGA will probably still solder successfully.

Poor alignment of the printed image is fundamental; even with manual or semi automatic printing the operator should have seen the printing error. Error can occur with fine pitch design on automatic printers when the tolerance of the board can vary. In the future, with

lead-free, we may see errors on printing between side one and side two of the board on small packages like 0201, due to thermal expansion and contraction of the laminate.

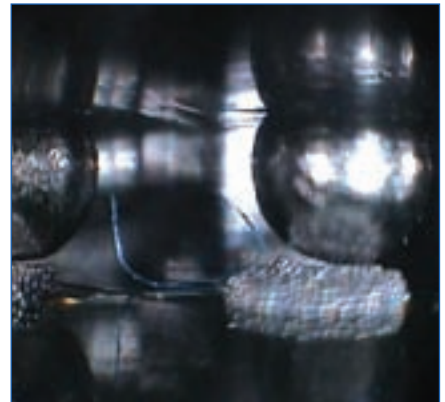
Figure 3. Contamination is not desirable in any production process.

Foreign debris

Any foreign debris on the printed board prior to printing will tend to be held on the surface of the board. If boards are left after printing, airborne contamination is often retained by the tacky paste deposits. BGA devices are sometimes found with debris on the balls or between the terminations when supplied. In most cases this is not conductive and even if it reflows in the joint it is burnt off.

It is certainly not desirable in any production process. Boards should be provided clean in suitable packaging, pasted boards should not be left to gather contamination, and contamination on BGAs should be highlighted to the supplier.

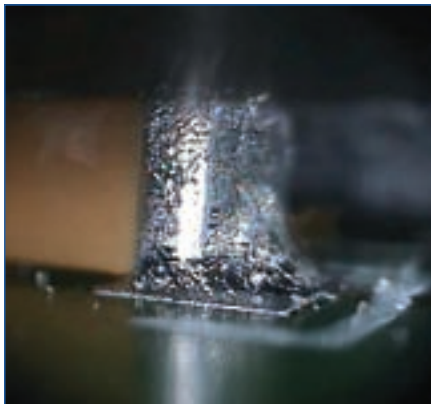
Figure 4. Chip capacitor with a tin termination soldered with tin/silver/copper lead-free paste.

Satisfactory lead-free joint

In Figure 4, a satisfactory joint has been produced, with the wetting line of the solder clearly visible around the joint. This is common with any termination or PCB finish that does not become liquidus during normal reflow soldering.

The board was reflowed with a peak temperature of 140°C and a temperature differential of 8°C with a seven-zone oven in air. It is important to remember when discussing reflow parameters to check on the oven in question as often engineers talk about the number of zones but fail to state the length of each zone.

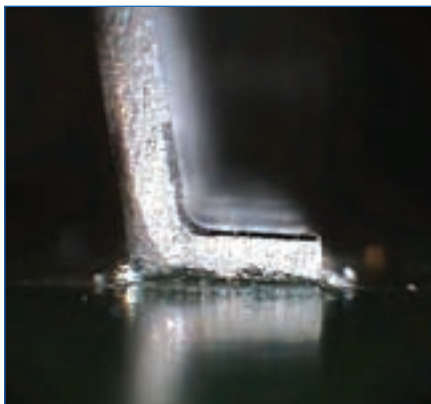
Figure 5. Lead-free joint on a gull wing lead with a tin finish.

Insufficient solder fillet

The solder joint shown in Figure 5 is outside the requirements of IPC 610 level 3 with very low heel and toe fillets. There is evidence of wetting all around the lead to pad interface.

There is a distinct line between the solder tin/silver/copper and the lead plating but this is common with lead-free alloys. The pull force required to remove this 0.020" lead from the pad would be in

the order of 600-800 g. As an example, some companies have a minimum of 450 g for tin/lead products.

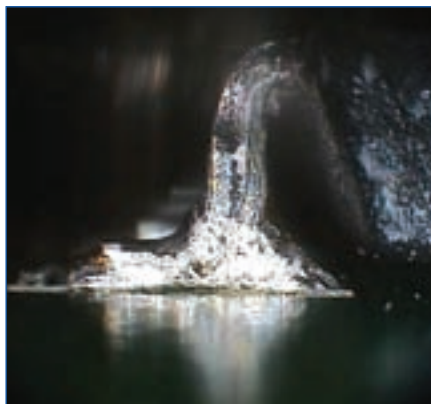
Figure 6. Lead-free joint on a SOIC after reflow soldering in a convection process.

Satisfactory gull wing joint

The joint in Figure 6 would meet the size and shape joint requirements for IPC610 level 3. Some inspectors may consider the surface of the joint unacceptable but this slightly rough surface is not untypical of lead-free joints.

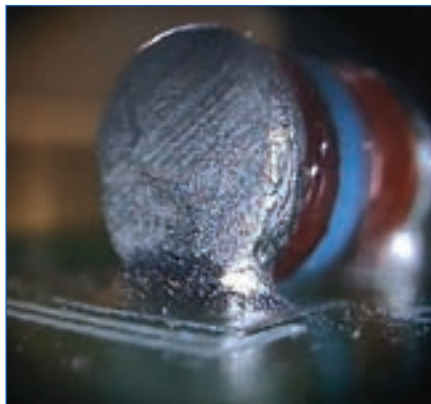
Figure 7. A MELF that has been reflow soldered using tin/silver/copper paste in a convection system.

Satisfactory lead-free joint on MELF termination

Reflow joints on MELF terminations often do not have the volume of solder to meet the minimum inspection criteria; however, they are seldom rejected. The MELF in Figure 7 has been reflow soldered using tin/silver/copper paste in a convection system. A satisfactory joint has been produced and the wetting line can be seen along the width of the termination.

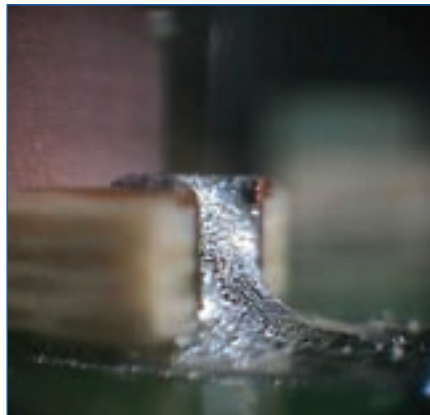
Figure 8. Example of a castellated termination on a lead-free light emitting diode (LED) soldered with tin/silver/copper paste.

Satisfactory castellated termination

The wetting to the pad and the surface of the termination in Figure 8 is good and exceeds the soldering standards of the IPC610.

The surface of the joint looks rough, but this is not untypical of some joints as they solidify on cooling and may be expected. During shear force measurements the LED exceeded the push force requirement, higher than tin/lead terminations of the same size.

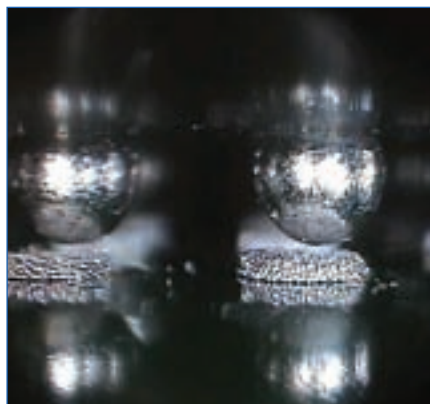
Figure 9. Another BGA package that has not been placed into the paste deposit.

Poor placement force control

Like the BGA package in Figure 1, the BGA package in Figure 9 has not been placed into the paste deposit; the ball terminations are sitting proud of the surface of the paste. This may be due to uneven paste deposit, a warped BGA or a random chip component under the BGA, which does happen from time to time.

Many people do not inspect boards after placement, those that do often use automatic systems that would not detect

this type of error which may lead to an open connection after reflow. Random sample inspection should be at the heart of any good robust process control program.

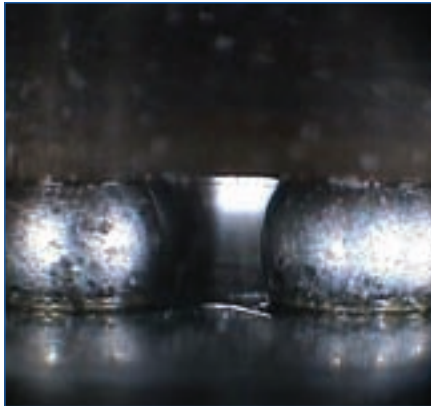
Figure 10. These two BGA joints show reduced wetting.

BGA pad joint wetting

Two BGA joints in *Figure 10* show reduced wetting on an OSP board surface; you can easily see the edge of the pads after reflow. This device had been operating successfully for three years and was in fact mechanically sound.

The degree of wetting on some surfaces can affect all components and this

example could be rejected simply due to the way it is viewed. This is probably an example where optical inspection would reject the soldering and x-ray accepts it. If this was found in current production, the quality of the PCB should be investigated to see if it is a batch solderability issue or a board that has been processed incorrectly.

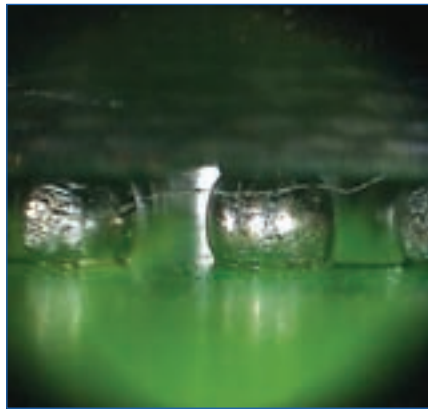
Figure 11. Foreign debris shown on a board.

More debris

Any foreign debris, hair or fibre on the printed board prior to printing will tend to be held on the surface of the board. It is not uncommon today for some sites to clean boards through two sticky rollers

prior to printing. If boards are left after printing airborne contamination is often retained by the tacky paste deposits. BGA devices are sometimes found with debris on the balls or between the terminations when supplied. In most cases this is not conductive and even if it reflows in the joint it is burnt off.

There is no real criteria for this type of contamination but it should be considered a process indicator requiring process improvement.

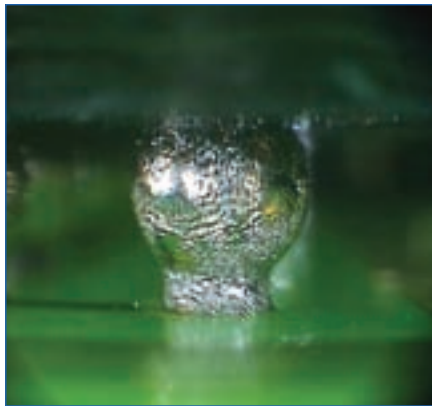
Figure 1. The ball in this figure has not started to reflow, indicating an incorrect profile.

Incomplete reflow of lead-free paste

The BGA in Figure 1 has lead-free terminations and is being reflowed with lead-free solder paste tin/silver/copper. The paste has started to reflow, but it has not completely reflowed. The ball has not started to reflow, so clearly the profile used on this assembly was incorrect. Generally it would be the peak temperature or the time at peak temperature that was incorrect on this example. It is feasible that too long a period at high pre-heat prior to reflow could have

exhausted the flux in the paste.

Certainly this would not be considered an acceptable joint.

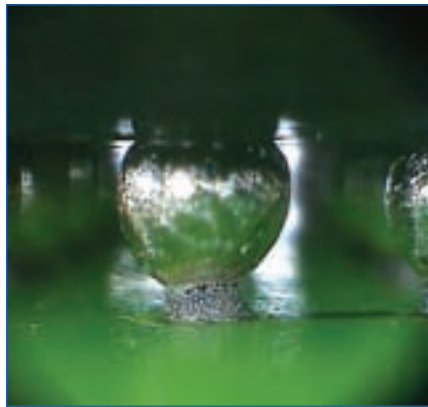
Figure 2. Close-up view of a lead-free BGA and non-reflowed solder paste.

Clearly in Figure 2, the assembly has not achieved the required temperature during reflow. The size of the paste deposit for a termination of this size should also be questioned—either the incorrect stencil aperture has been used or the paste release

from the stencil needs to be investigated.

Either of these issues could lead to open circuits if warping of the device takes place.

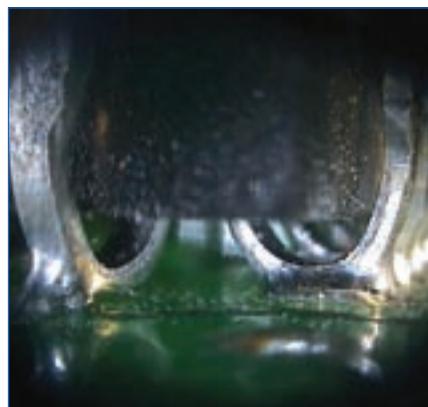
Figure 3. The joints have not formed under the body of this part.

Lead-free J lead joints

The two joints in Figure 3 have soldered on the front face of the pins, which would normally be easily seen during inspection at low magnification, but the joints have not formed under the body of the part.

This is probably due to solderability problems with the printed board and are not related to the lead-free process.

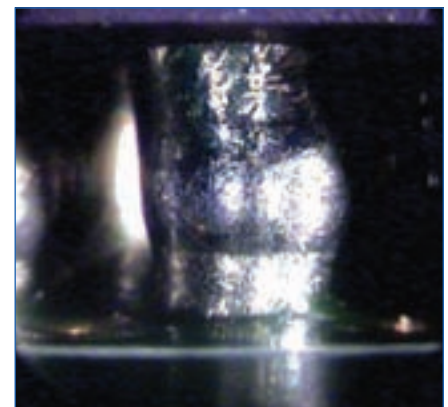
Ceramic ball grid array joint

Figure 4 is fairly typical of a tin/lead joint formed on CBGA terminations. As the ball is a high temperature 90% lead/10% tin termination it does not become liquid during normal reflow. When the solder paste reflows with a peak temperature of between 210-220°C, the tin/lead paste will wet the pad and climb up the ball termination. This means there will always be a demarcation line between the solder and the ball. The line around the ball at the top of the joint is how the ball is initially soldered to the package.

Figure 4. Typical tin/lead joint formed on CBGA terminations.

If you do a microsection of this joint you would still see the perfect ball sitting between the two joints.

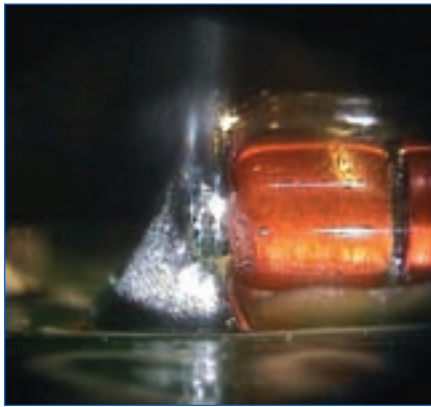
Figure 5. A perfectly satisfactory lead-free joint.

MELF Lead-free wave solder joint

The side view of a lead-free solder joint shown in Figure 5 was produced with tin/silver/copper alloy and is a perfectly satisfactory lead-free joint. The solder surface shows evidence of the lines often seen in lead-free joints formed during solidification of the alloy and is a surface effect. This example was produced on a double wave with a solder temperature of 260°C and water-based, no-clean flux technology.

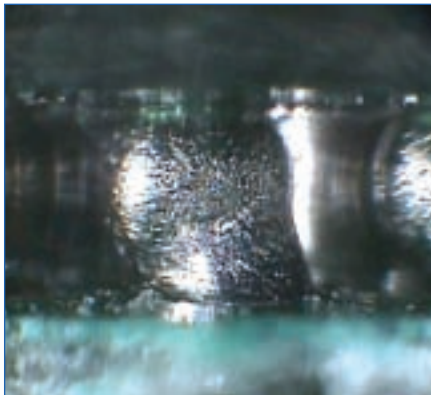
Figure 6. A casualty of the transition from a tin/lead process.

Lead-free BGA with tin/lead solder

Figure 6 is fairly typical of what can be seen during the transition from a tin/lead process and lead-free. More and more component suppliers are changing to lead-free terminations, which do not reflow at normal tin/lead solder paste process temperatures.

What is seen in this example is the result of reflowing tin/lead paste at 210-220°C which is normal. If the ball had been tin/lead, the termination would have reflowed and the solder and the ball would have

coalesced together to form a perfect joint. In this case the reliability of the joint may be perfect, as the solder has wetted the ball; however, there will be a lot of debate on this issue for some time.

The key point is to be informed by suppliers when and on what batches changes to alloy will occur.

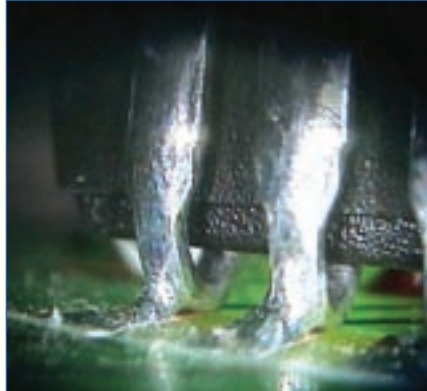
Figure 7. Joints that have not formed under the body of the part.

Lead-free J lead joints

The joints in Figure 7 have soldered on the front face of the J leads. This would normally be easily seen during inspection at low magnification. The joints have not formed under the body of the part. In this case the base pad finish was copper OSP treated. This problem is probably due to OSP solderability problems with the printed board and not related to the lead-free process. These joints would be outside of the criteria for IPC 610.

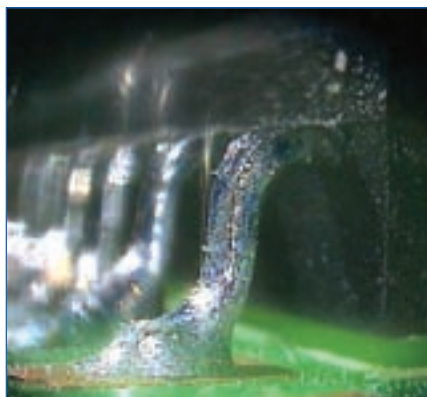
Figure 8. These lead-free joints have failed to wet correctly.

Gull wing leads

Figure 8 shows an example of lead-free joints on gull wing terminations that have failed to wet correctly. The board had been wave soldered with tin/copper/nickel, and the OSP pad had not wetted fully, probably due to

some problems with the surface of the copper. This would be outside of the requirements of IPC 610.

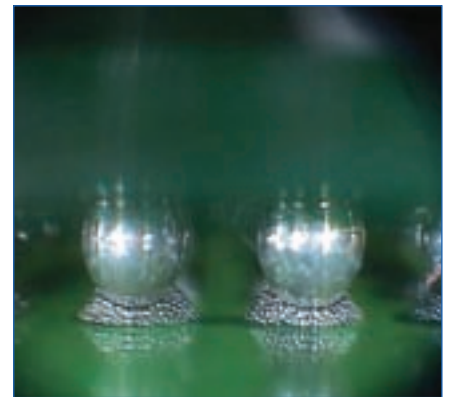
Figure 9. The balls in this part are plastic with a metallised solderable coating.

Correct BGA alignment

Clearly the solder paste has not reflowed in Figure 9, but the position of the balls in the paste is correct. The board assembly was being inspected prior to reflow for position of the terminations. This device is different than most as the balls in this example do not collapse during reflow and help improve joint reliability. The difference with this part is the balls are plastic with a metallised solderable coating.

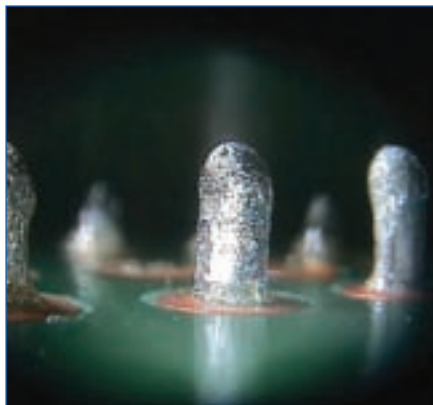
Figure 11. An incorrect profile resulted in partial reflow on the pin.

Incomplete reflow of lead-free paste

Figure 11 shows an example of pin-in-hole (PIH) reflow of a through-hole connector with lead-free solder paste. The profile of the area of the board was not correct, resulting in partial reflow on the pin. The solder paste has been pushed out along and over the pin tip; it has started to reflow. Push out of paste is common with the process, but the time in a liquid state needs to be long enough for the solder to completely reflow, wet the pin and plated through-hole, and then coalesce back into the hole to form the through-hole fillet. If it does not, it gives a good coating on the pin but little value to the joint.

Through-hole parts are normally the most thermally demanding parts on the board and need to be correctly profiled particularly for lead-free assembly.

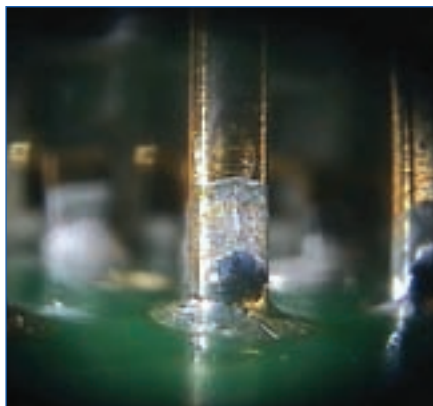
Figure 12. This through-hole connector has been satisfactorily soldered.

Lead-free through hole reflow

Figure 12 shows a satisfactory topside view of a through-hole connector reflow-soldered using tin/silver/copper paste. The joints all had a 100% fill and positive fillets on both sides of the board assembly. The Harting connector pins are gold flash over nickel, provided as the company's lead-free option.

Modifying the temperature profile provided a perfect joint with 100% fill of the plated through hole, easily meeting IPC610 requirements.

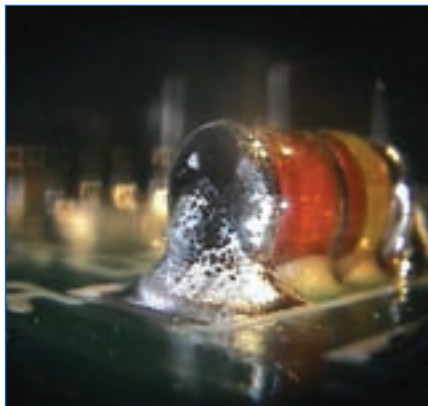
Figure 13. The lines on this joint are merely a surface effect.

MELF lead-free wave solder joints

The lead-free solder joint in Figure 13 was produced with tin/silver/copper alloy and is a perfectly satisfactory lead-free joint. The solder surface shows evidence of the lines often seen in lead-free joint formed during solidification of the alloy and are a surface effect. This example was produced on a double wave with a solder temperature of 260°C and a water-based, no-clean flux.

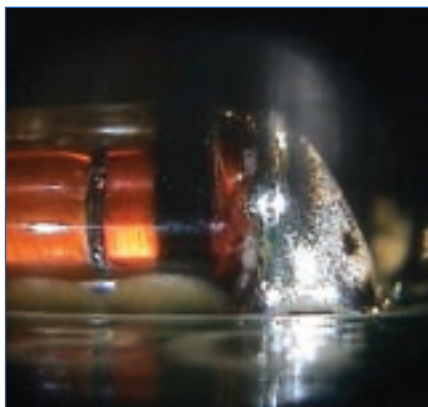
Figure 14. Although this joint is bulbous, it still meets inspection criteria.

This side view of a lead-free solder joint in Figure 14 was produced with tin/silver/copper alloy and is a perfectly satisfactory lead-free joint. The joint is bulbous in its appearance but still meets the inspection criteria. The solder surface shows evidence of the lines often seen in lead-free joints formed during

solidification of the alloy and is a surface effect. This example was produced on a double wave with a solder temperature of 260°C and water-based, no-clean flux technology.

It is not uncommon for lead-free joints to be fuller in their appearance, due to the poor drainage of most alternative alloys.

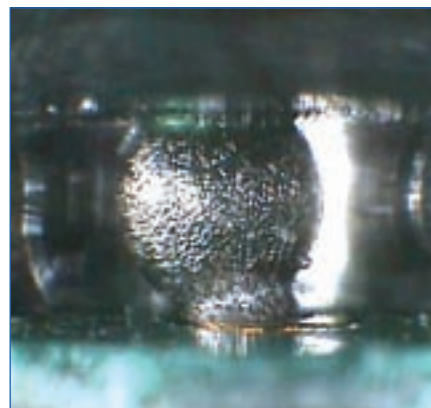
Figure 15. The paste has reflowed and wet the pad and the ball termination, but the ball has not reflowed.

Lead-free BGA joint

Figure 15 shows a lead-free termination reflowed with tin/lead paste. The paste has reflowed and wet the pad and the ball termination; the ball has not reflowed. There are a number of issues here: small volume of paste, limited wetting on the pad and lead-free termination with tin/lead paste.

The limited wetting to the pad may be as a result of the small volume of paste available rather than a specific issue with solderability. The process needs to be reviewed for print quality and solderability of the pad finishes. BGAs being supplied as lead-free without the supplier informing the vendor must be avoided.
