GLOBAL SMT & PACKAGING

Volume 8 Number 5 May 2008

Ball grid array & lead-free assembly defects, part 1

Ball grid array & lead-free assembly defects, part 2

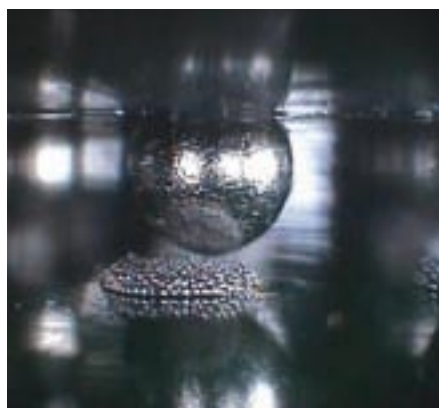
Figure 1. The BGA package has not been placed into the paste deposit.

In Figure 1, the BGA package has not been placed into the paste deposit; the ball terminations are sitting proud of the surface of the paste. This may be due to uneven paste deposits, a warped BGA or a random chip component under the BGA, which does happen from time to time.

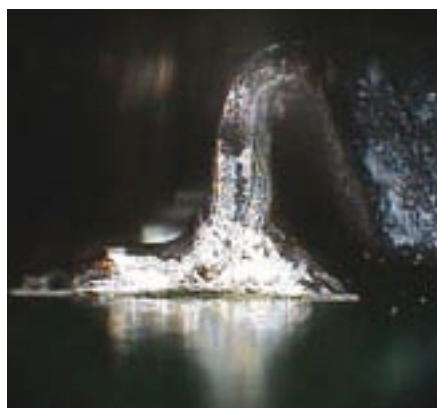
Figure 6. Lead-free joint on a SOIC after reflow soldering in a convection process.

The joint in Figure 6 would meet the size and shape joint requirements for IPC610 level 3. Some inspectors may consider the surface of the joint unacceptable but this slightly rough surface is not untypical of lead-free joints.

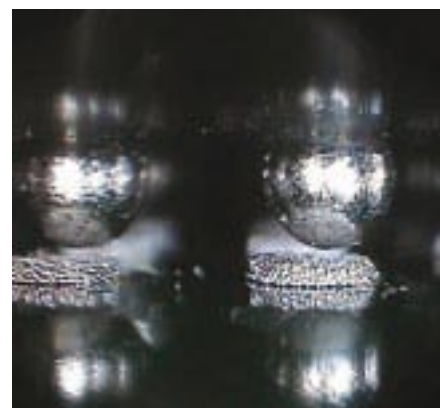
Figure 9. Another BGA package that has not been placed into the paste deposit.

Like the BGA package in Figure 1, the BGA package in Figure 9 has not been placed into the paste deposit; the ball terminations are sitting proud of the surface of the paste. This may be due to uneven paste deposit, a warped BGA or a random chip component under the BGA, which does happen from time to time.
